**The Office of Oversight conducted a followup review of groundwater tritium contamination at the BNL HFBR.**

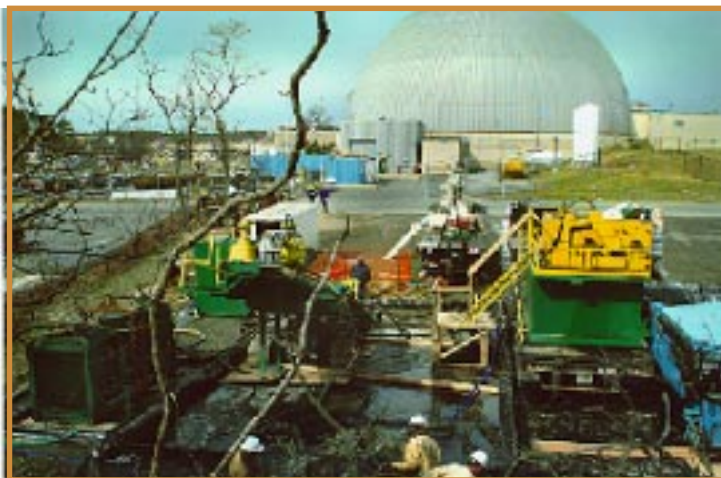
**Horizontal Drilling To Detect Contamination beneath the Fuel Pool at the High Flux Beam Reactor**
